7. Photographs

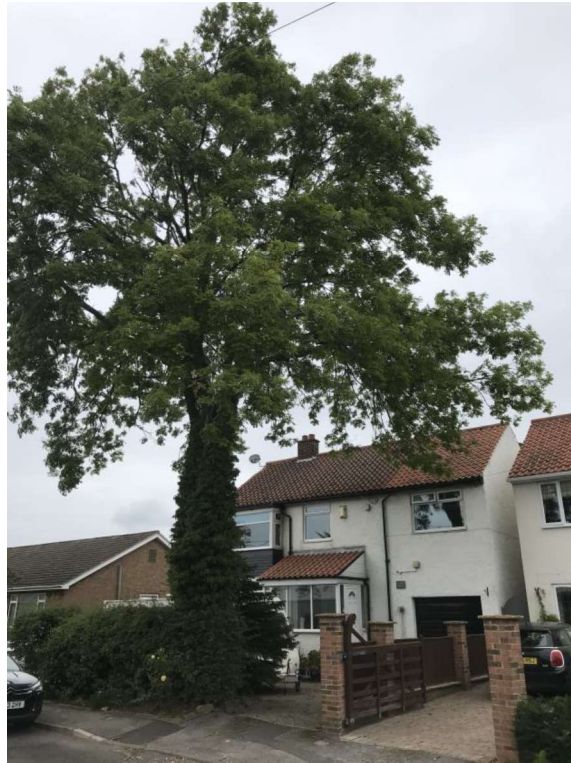
7.1. Front elevation showing Ash tree

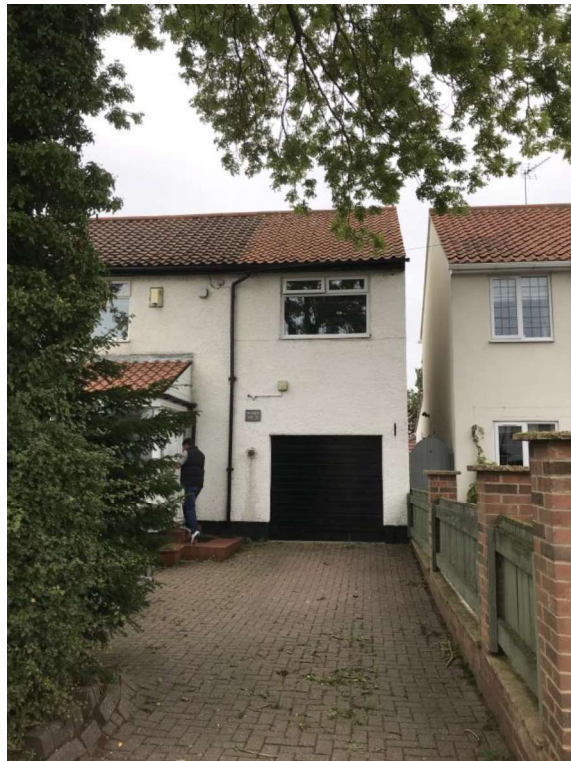
7.2. Partial front elevation and driveway

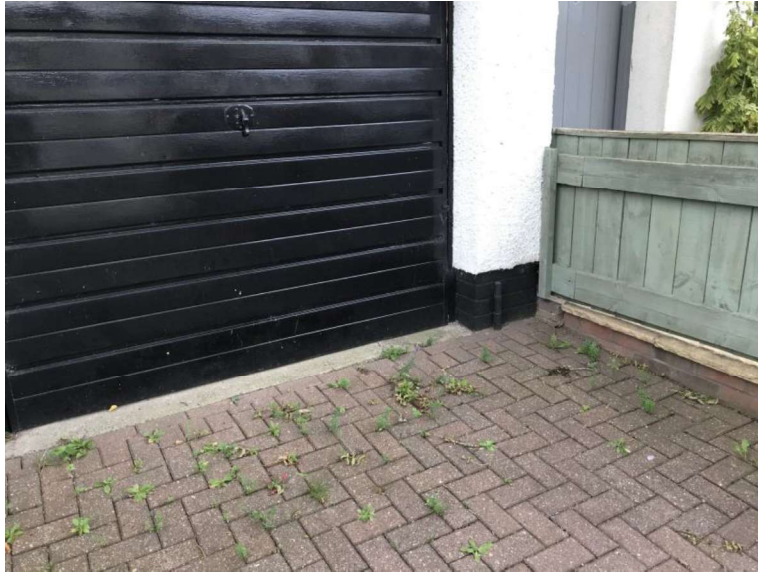
7.3. Gas pipe location to front right corner of property

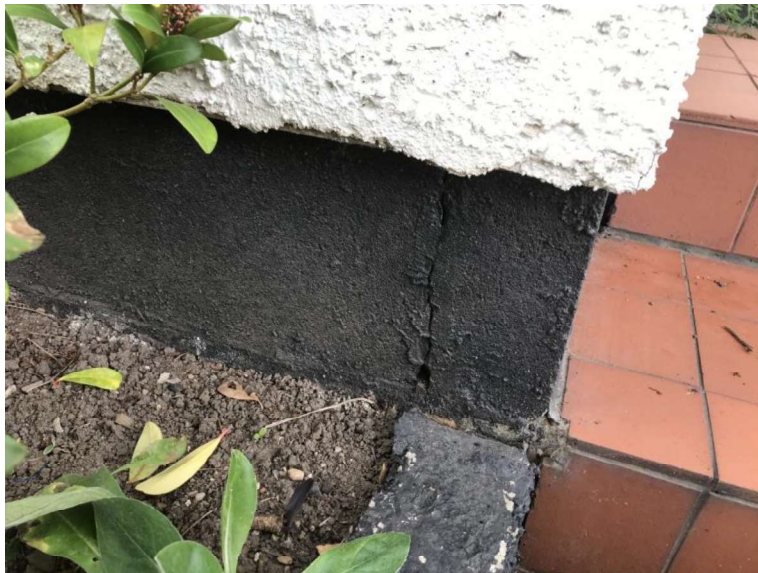
7.4. Crack to porch corner – thermal shrinkage

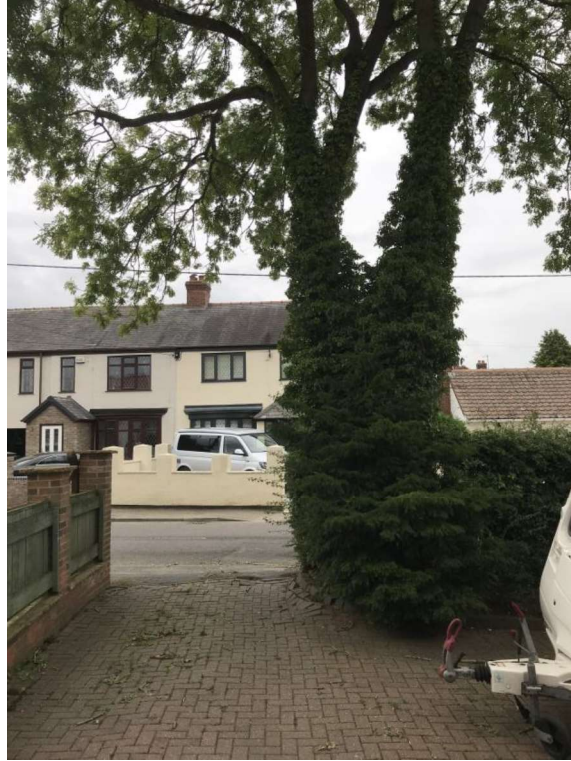
7.5. Tree and drive

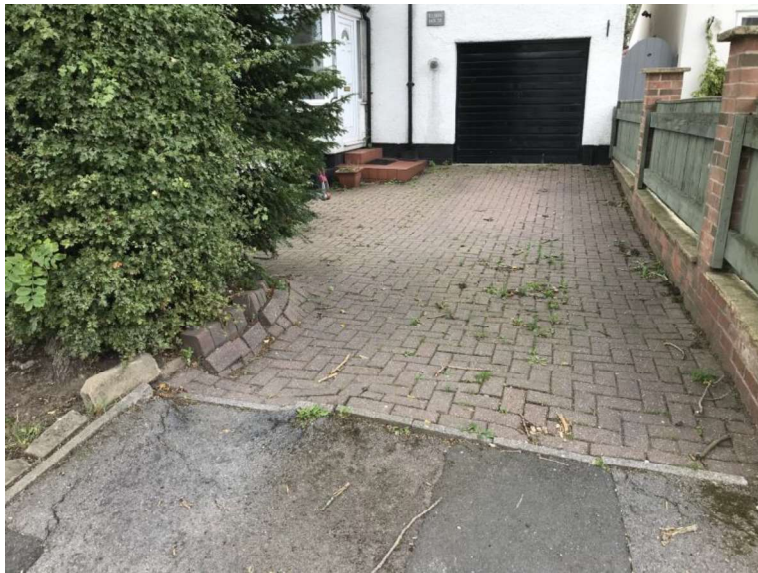
7.6. Damage to drive and highway pavement through tree root action

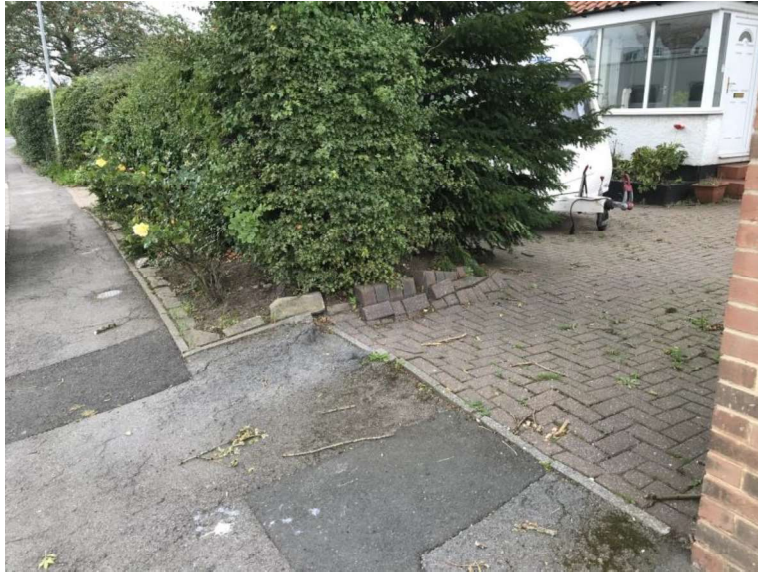
7.7. Damage to drive and highway pavement through tree root action

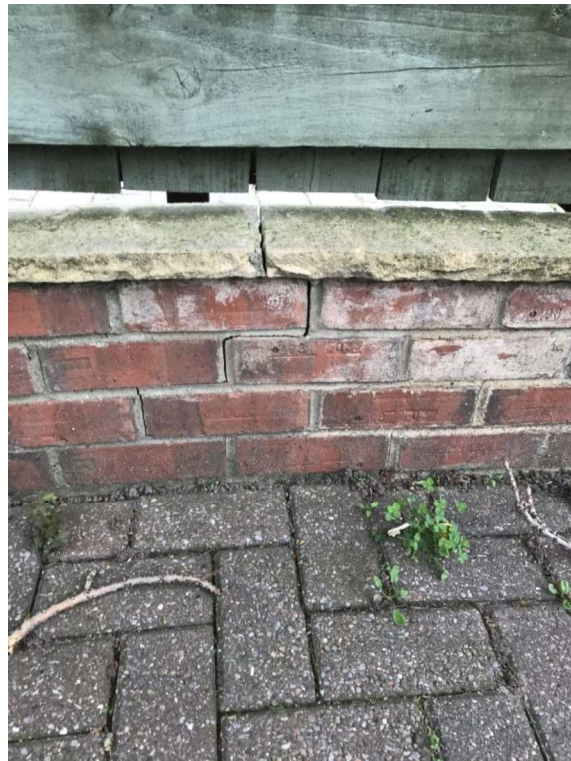
7.8. Crack and “broken back” to right boundary wall

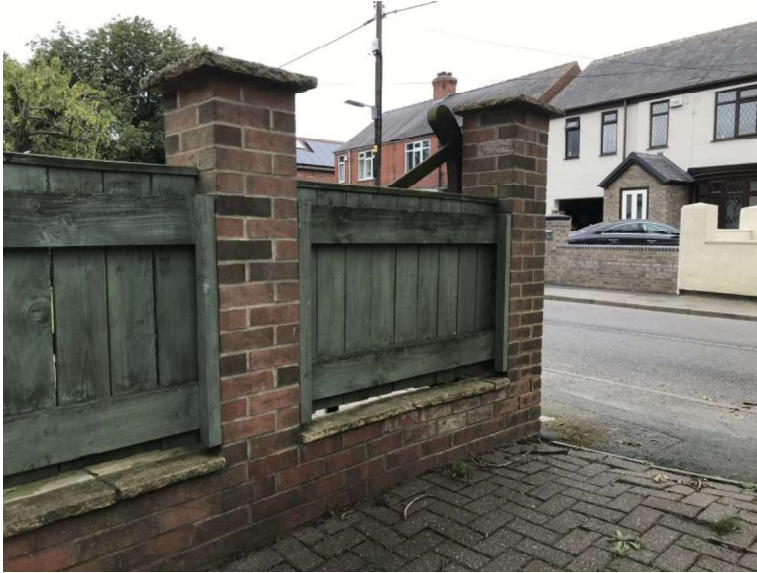
7.9. Crack and "broken back" to right boundary wall
