# **Lead Local Flood Authority Flood Investigation Report**

**Tees Tidal Flooding  
5<sup>th</sup> December 2013**

**Final Report**

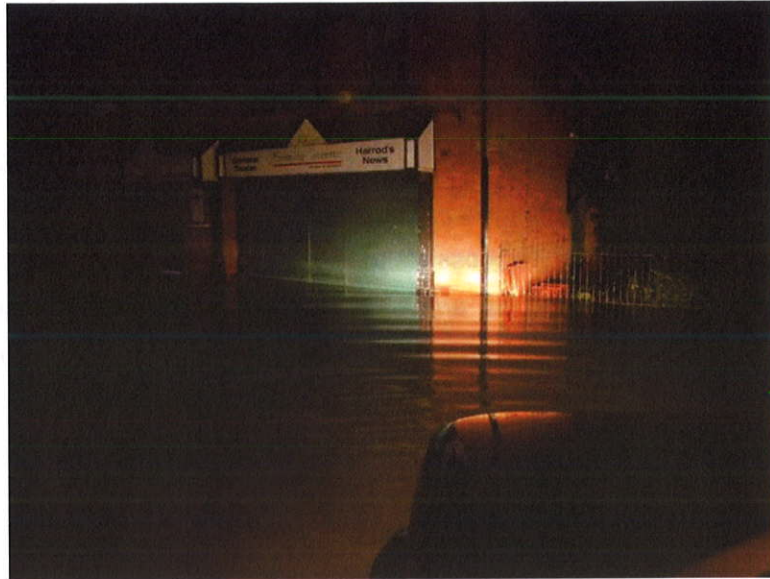
**Port Clarence – Shopping Parade**

Officers from the Councils Technical Services Division attended site and became concerned about the height of the tide. Following this communication Officers from across the Council put the Emergency Plan into practice with Technical Services Officers setting up a Command Centre within Kingsway House, Billingham and Officers from Direct Services sand-bagging more strategic locations within The Clarence's to prevent inundation in the event of the defences being overtopped. In addition to this Council Neighbourhood Enforcement Officers were deployed to the area and Vela Homes were made aware of the potential emergency situation and attended site.

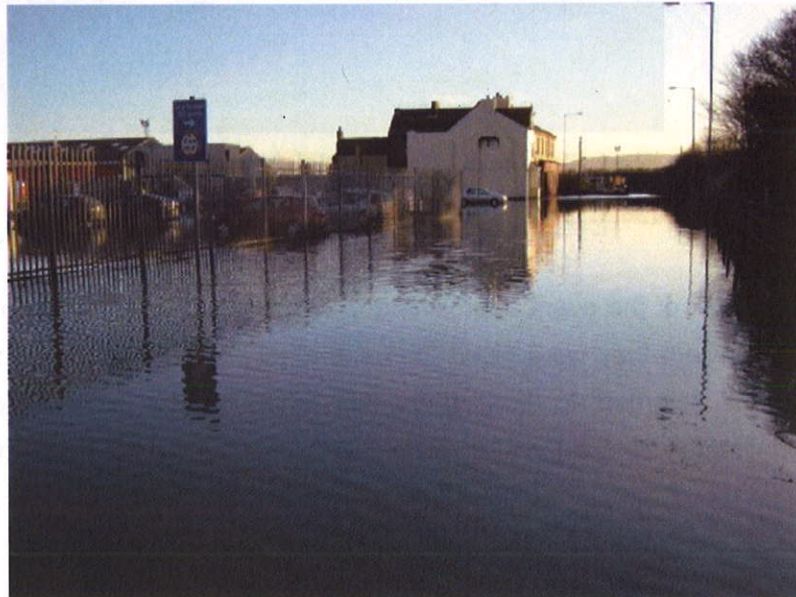
**Port Clarence - Calor Gas Site**

As the afternoon progressed, it had been expected that information would be available from the peak tide in Aberdeen to give an indication of any potential surge heights. When the tidal surge 'hit' the lowest defences at Wilton Engineering and Billingham Reach Industrial Estate were overtopped and the site inundated, which led to the decision to evacuate Port Clarence.

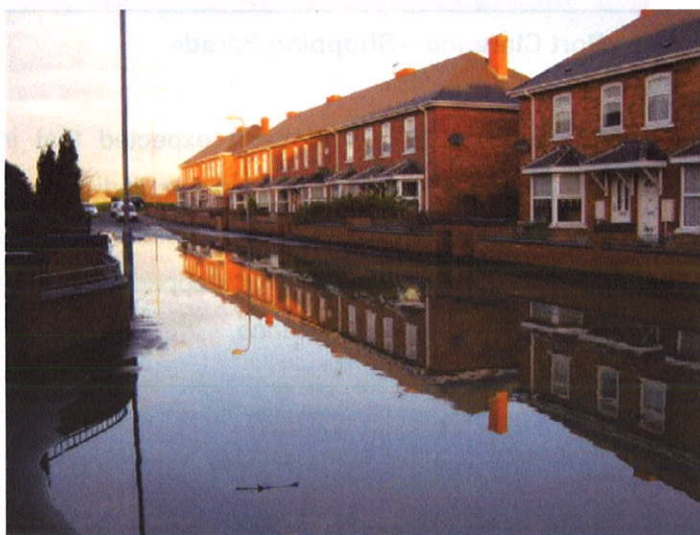
**Port Clarence – Residential Area**

Over the next few of hours, through a combined effort of the Council and Emergency Services, all residents of Port Clarence who wished to be evacuated, were transported to the designated rest centre, which had been set up at Billingham Forum. In addition to this, approximately 100 people who had become trapped at Wilton Engineering were evacuated by the Council, as the flood water had cut off egress points, making it impossible to leave the site in a normal car. Shortly after the defences were over-topped, an electricity substation was inundated with flood water causing a widespread power outage, plunging a large part of the Billingham, Stockton and Middlesbrough areas into darkness. This further complicated the evacuation process.

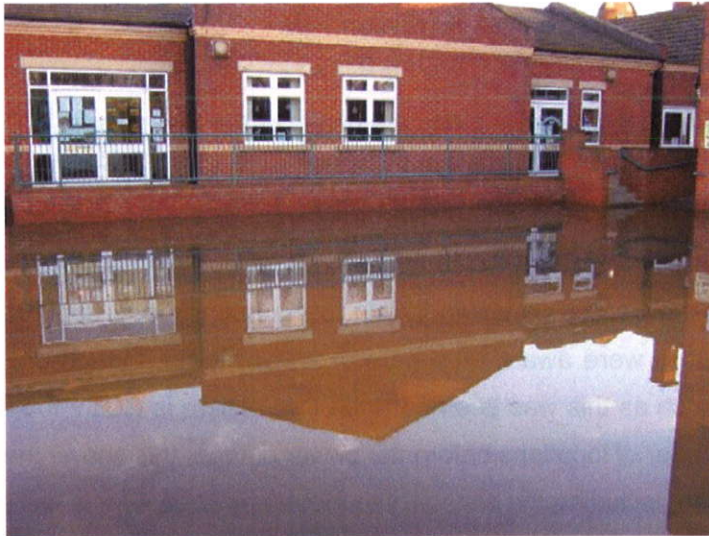
**Port Clarence – School**

At the peak of the event approximately 250 residents were evacuated to Billingham Forum, where they were given food and other essential items. The majority of the residents returned to their properties when it was safe to do so, although approximately 20 residents chose to stay for the night at the rest centre.

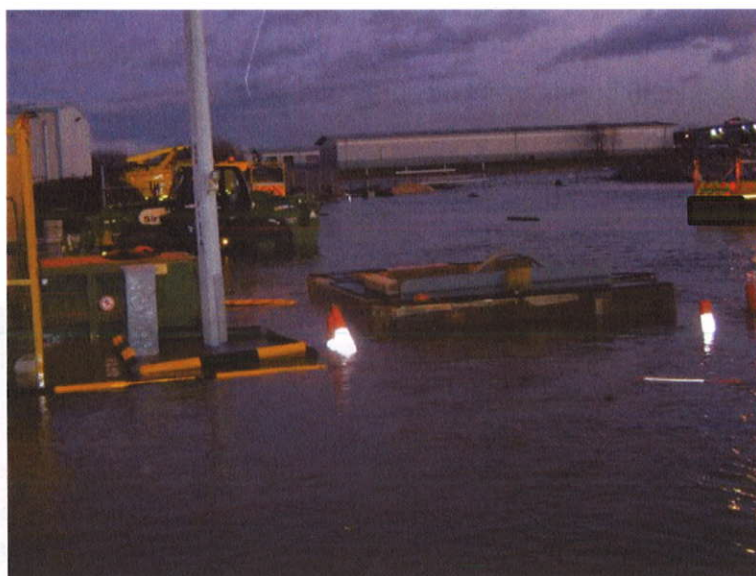
**Sir Robert McAlpine Autolink Premises**

The businesses struggled to evacuate staff due to the speed of the surge and the fact they were not expecting it, due to the late issue of flood warnings. Most of the businesses were aware they were in a flood zone, though the probability of a tidal event such as this was deemed to be low. There is CCTV footage of the inundation in a number of locations before the power outage; this shows the speed and power of the surge, including the capability to move any large item in its flow path.

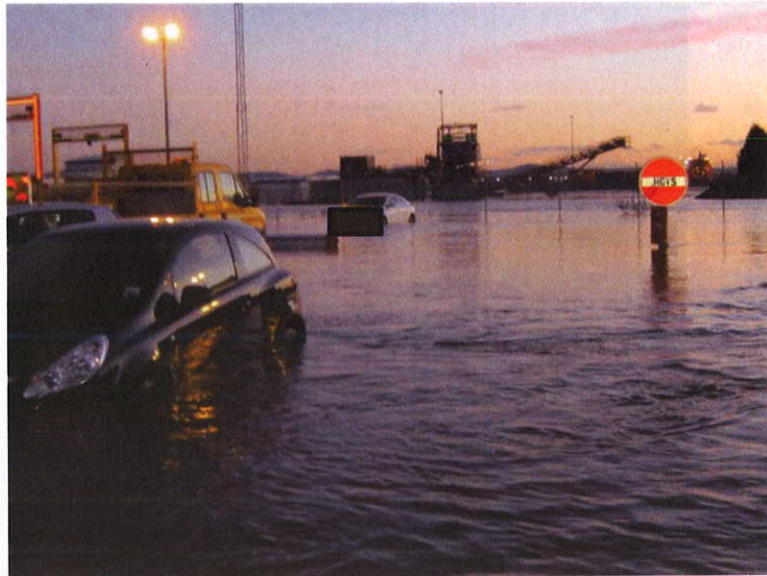
**Sir Robert McAlpine Autolink Premises**

A large amount of damage was caused to individual business premises and a large number of vehicles were written off at various locations, due to the speed of the surge the vehicle owners were unable to remove them in time. The repairs to businesses are still on going and the economic costs are still rising and likely to be many millions of pounds.

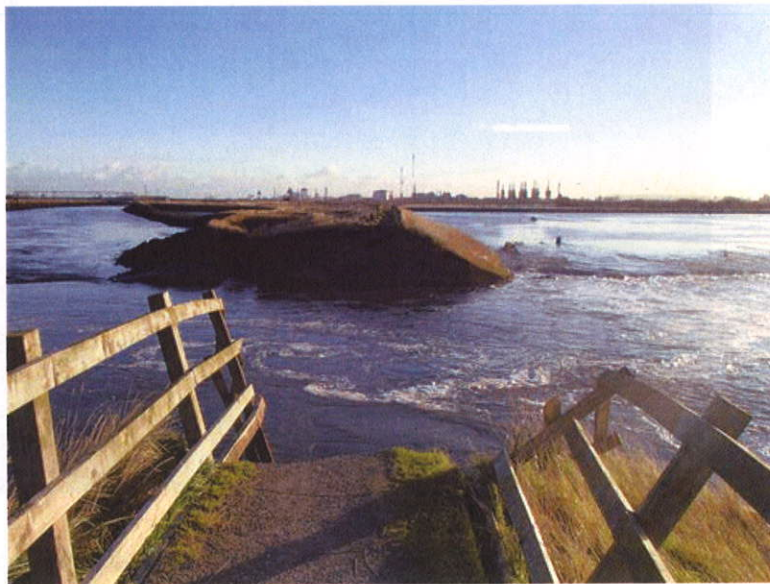
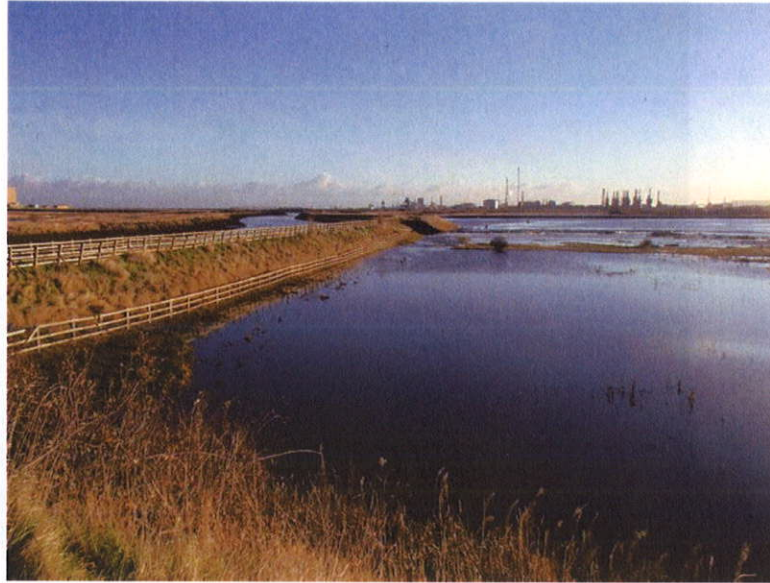
A flood bank on the Southern side of Greatham Creek, downstream of the A178 failed during the tidal event, leading to a very significant breach in the defences.

Improvements to the flood bank are being considered as part of the project for Port Clarence and Greatham South.

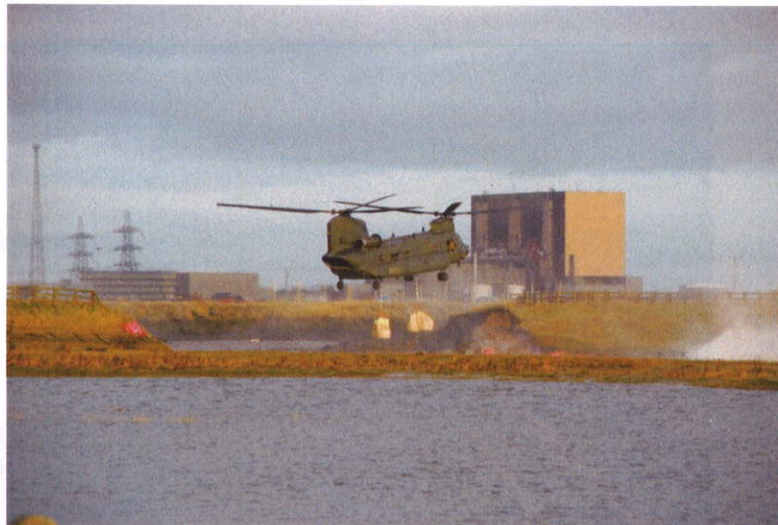
The Environment Agency mobilised immediately and engaged the military, as there was no access to the breach due to the wide spread flooding. A large area of land was flooded due to the breach which had a significant impact on the local industry and infrastructure but also the wider chemical industry, due to businesses having to shut down and breaking the supply chain.

The Environment Agency, their contractors and the Military worked around the clock to seal the breach as quickly as possible due to the threat from further high tides, leading to a worsening of conditions. An Acoustic Radio Controlled Boat was used to carry out an underwater survey of the breach. This revealed the depth of the breach to be -4.8m AOD, the visible extents of the breach above ground were approximately

50m in length. The A178 was flooded due to the breach and remained fully closed for several weeks while the temporary works were undertaken and site prepared for the permanent work. Thousands of tonnes of rock, stone and clay had to be imported to site and the work is still on-going at the time of writing of this report. Though, the road has now re-opened, temporary traffic management restricting vehicular flows still remain in place.

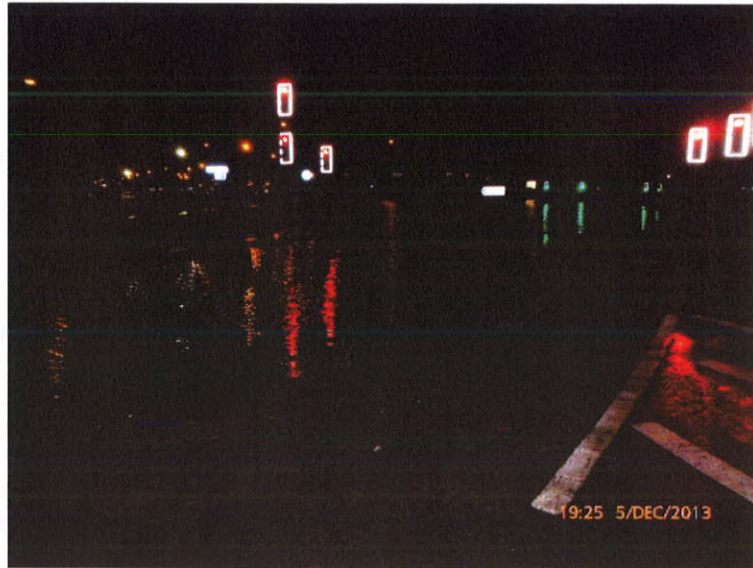
**A19 Portrack Interchange**

The tributaries of the River Tees and Billingham Beck were also affected by the surge, backing up and causing flooding of the A19 Portrack Interchange up to approximately 1 metre deep. This interchange is one of the busiest in the area and the flooding coincided with the evening peak traffic flows, causing widespread traffic disruption across Stockton and beyond.

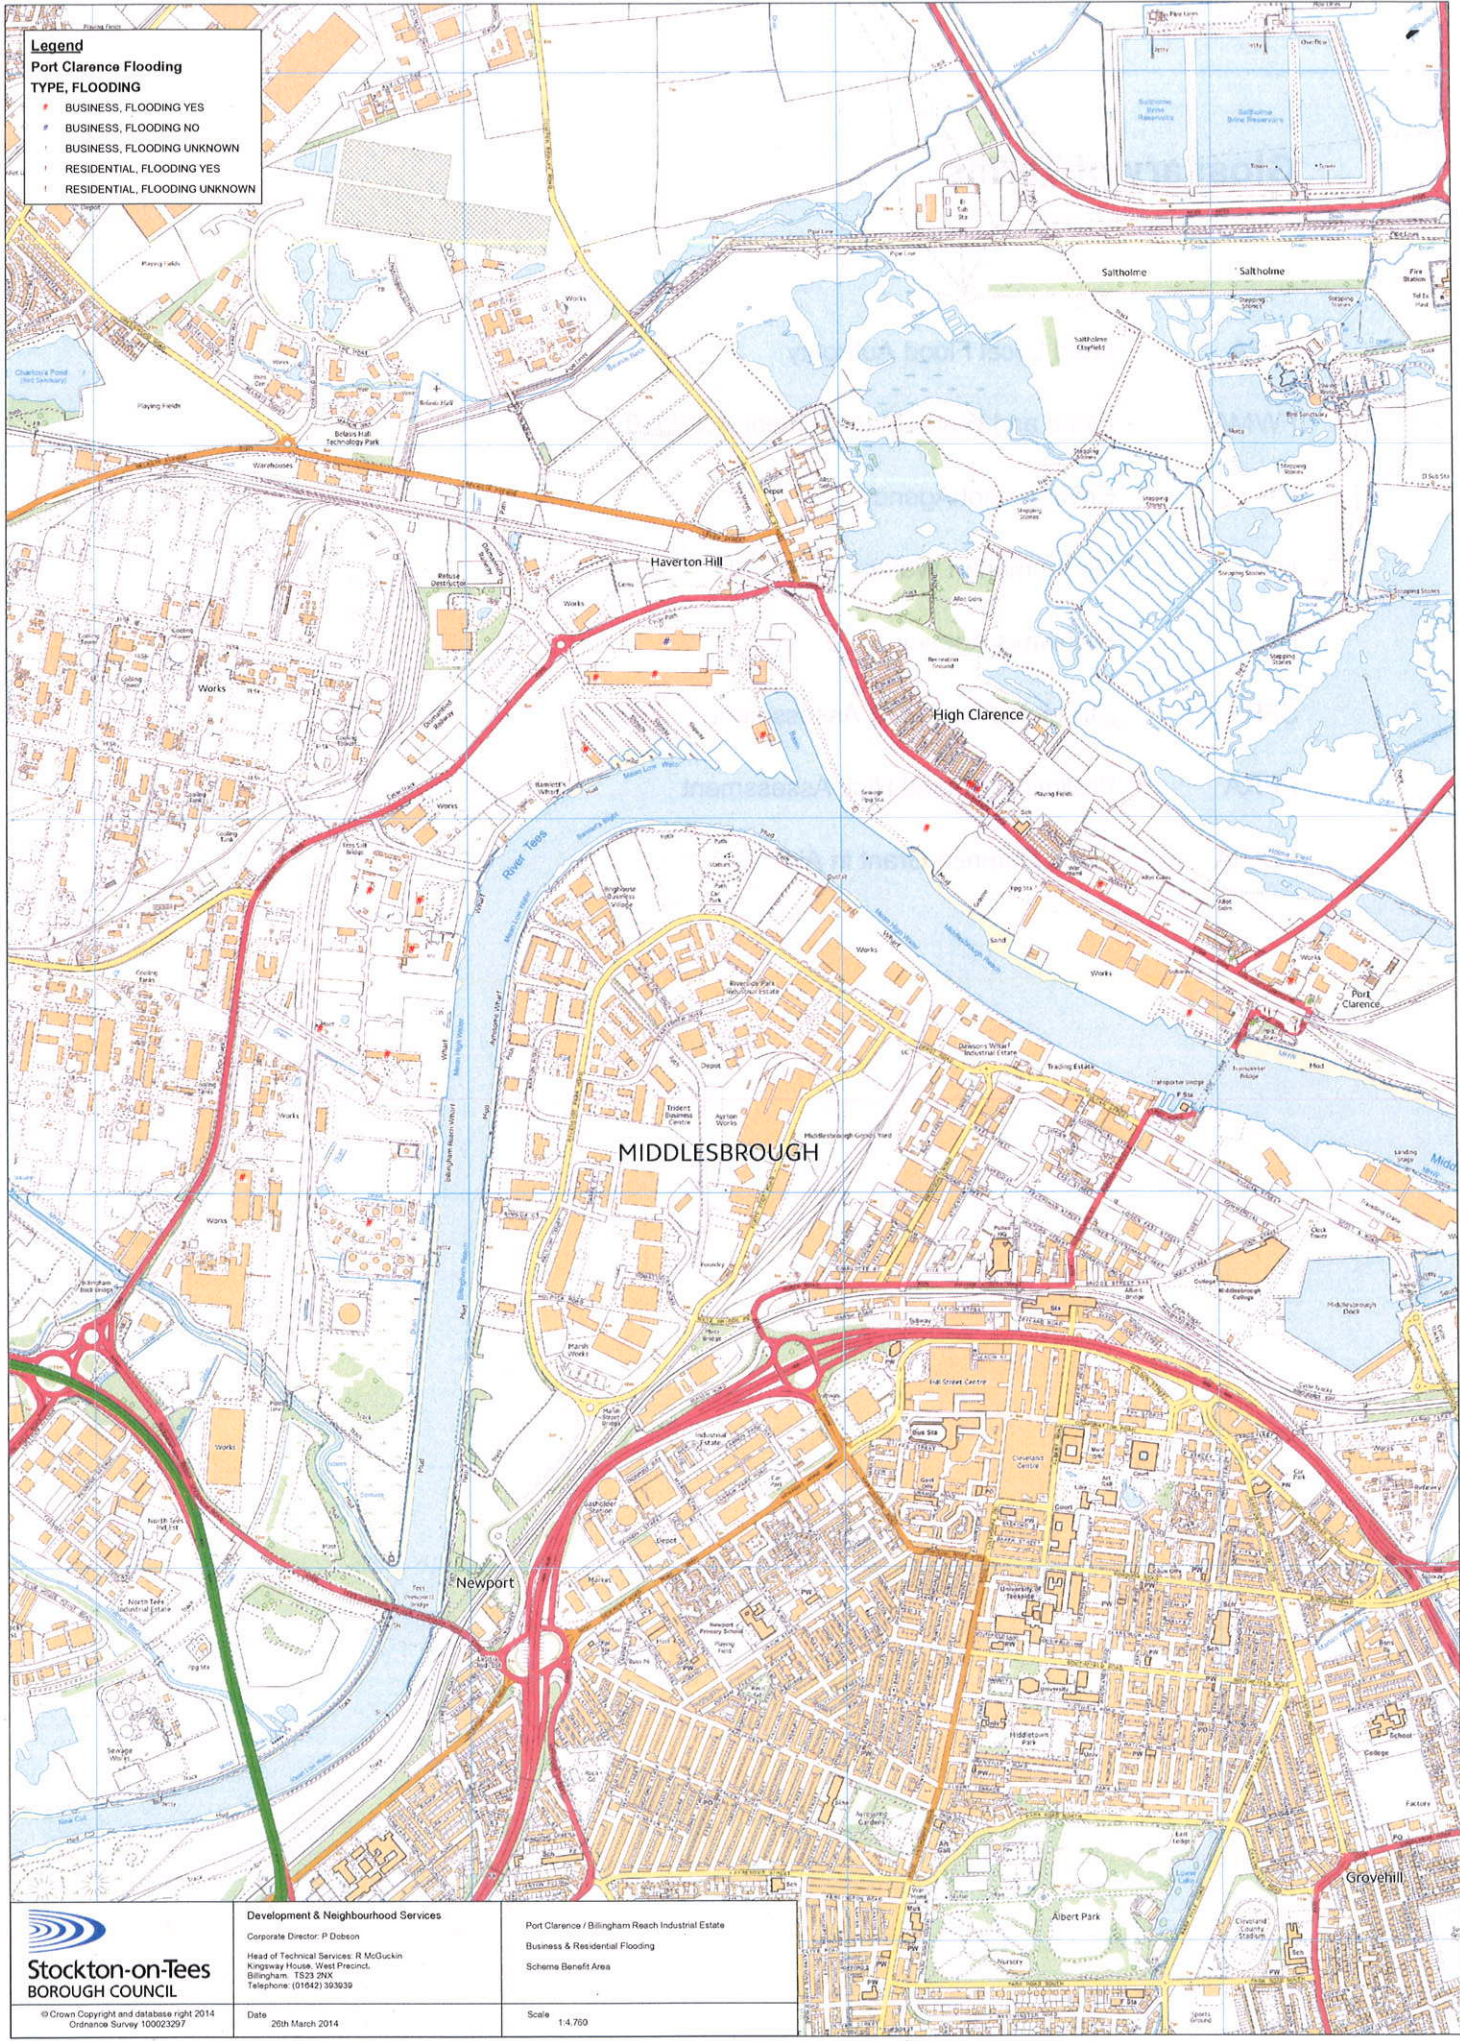
**Appendix 5**

**Legend**  
**Port Clarence Flooding**  
**TYPE, FLOODING**
